✓
Technical Note N-859

CORROSION RATES OF SELECTED ALLOYS IN THE DEEP OCEAN

J. B. Crilly and W. S. Haynes, Ph. D.

U, S. NAVAL CIVIL ENGINEERING LABORATORY
Port Hueneme, California

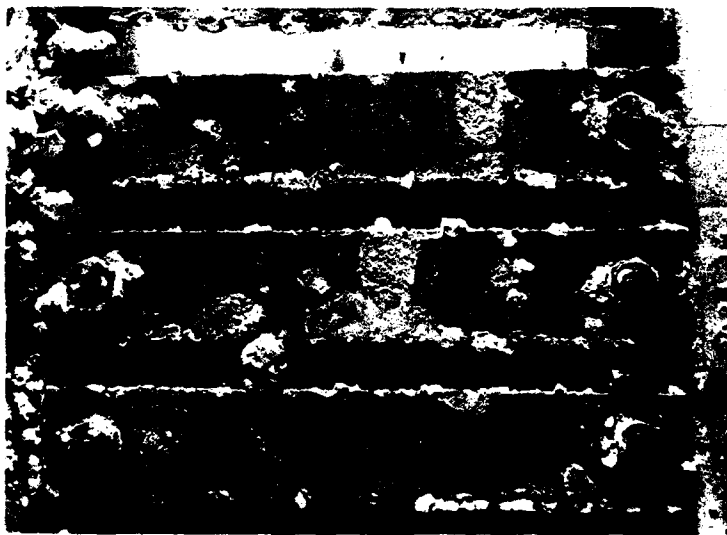
Figure 8. Sample 72, Aluminum 2024-T3;
QQ-A-362

around the nylon bolt heads; and, aluminum 2024-T3, with some surface pitting, some corrosion under the nylon bolt heads, and severe crevice corrosion resulting in a layered structure. Samples of the last three sets corroded at rates between 5.0 and 6.0 MDD: aluminum 7178-0, with severe pitting spreading to sizeable areas in some cases to perforation; bronze, with many small tubercules, and larger ones evident about some of the nylon bolt heads; and, naval brass, which did not appear seriously corroded in spite of the high corrosion rates, suggesting dezincification.

Alloy	Sample No.	Corrosion Loss, MDD*	Corrosion Rate, MPY**
Aluminum 2024-T3	S-72	3.6	1.9
Some corrosion under the nylon bolt heads; some surface pitting. Very severe crevice corrosion to give a layered structure. Figure 8.			
Ni-Cu 400, Annealed	S-73-1	5.0	0.81
	S-73-2	4.8	0.78
	S-73-3	5.8	0.94
	S-73-4	5.0	0.81
	S-73-5	3.2	0.52
Tubercules evident along sawn edges which were removed upon cleaning to reveal nicks along the edges. Severe tuberculation around nuts in all cases. Figure 16.			
Ni-Cu 400 (different heat from No. 73)	S-74-1	6.5	1.1
	S-74-2	5.1	0.83
	S-74-3	8.1	1.3
	S-74-4	7.5	1.2
	S-74-5	7.3	1.2
Severe tuberculation and crevice corrosion under all nuts. Some but not all edges showed corrosion damage, although all the ends did; tubercules present in isolated areas on the surface. Figure 17.			
Wrought Iron	S-132	3.1	0.58
Even corrosion with no pitting. Figure 25.

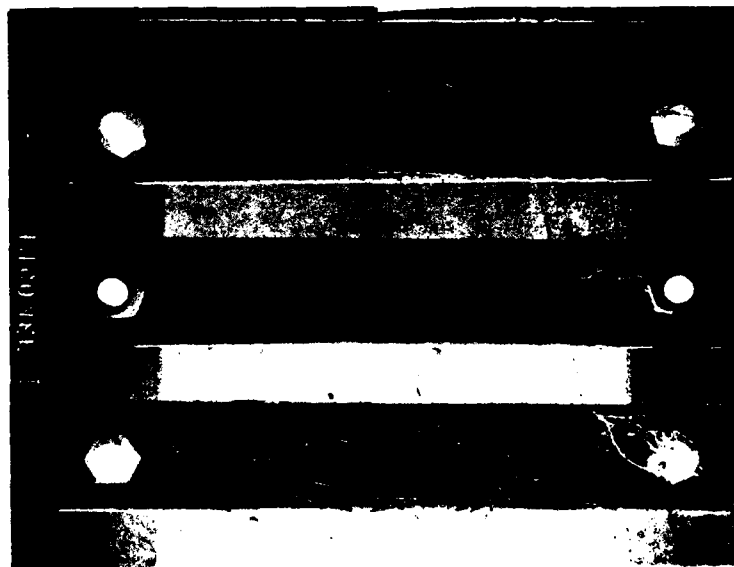
Figure 18. Sample 53, Ni-Cr-Fe-Ti X-750;
AMS-5542-D

Alloy	Sample No.	Corrosion Loss, MDD*	Corrosion Rate, MPY**
Ni-Cr-Fe-Ti X-750	S-53-1	0.01	0.00
	S-53-2	1.2	0.21
	S-53-3	0.01	0.00
	S-53-4	0.06	0.01
	S-53-5	2.1	0.37
Two of the specimens corroded under the nut, burrowing underneath the metal surface; overall loss not great but effect is quite concentrated where it does occur. Other three specimens show negligible corrosion. On specimens 53-2 and 53-5, deepest pit was 36 and 47 mils; average of ten deepest pits was 22 mils, 37 mils. Figure 18.			
Ni-Cr-Fe-Ti 600, Cond. A	S-54-1	0.01	0.00
	S-54-2	0.01	0.00
	S-54-3	0.01	0.00
	S-54-4	3.1	0.53
	S-54-5	0.01	0.00
In the one specimen there were isolated pits about the nuts; the other four showed very little sign of deterioration. On 54-4 the deepest pit was 51 mils and average of the ten deepest was 39 mils. Figure 19.			
Ti-4Al-3Mo-1V	S-55	0.00	0.00
No surface change apparent. Figure 26.			
Ti-140A (not a standard alloy)	S-56	0.00	0.00
